## Water Pollution Disaster in Tshikapa and Kasai Rivers Identified in the CB-CIS Tool: CRREBaC's Call for Action

Author: CRREBaC, Ref. No.: CRREBaC/RTM/043/082021, Kinshasa, 13 August 2021

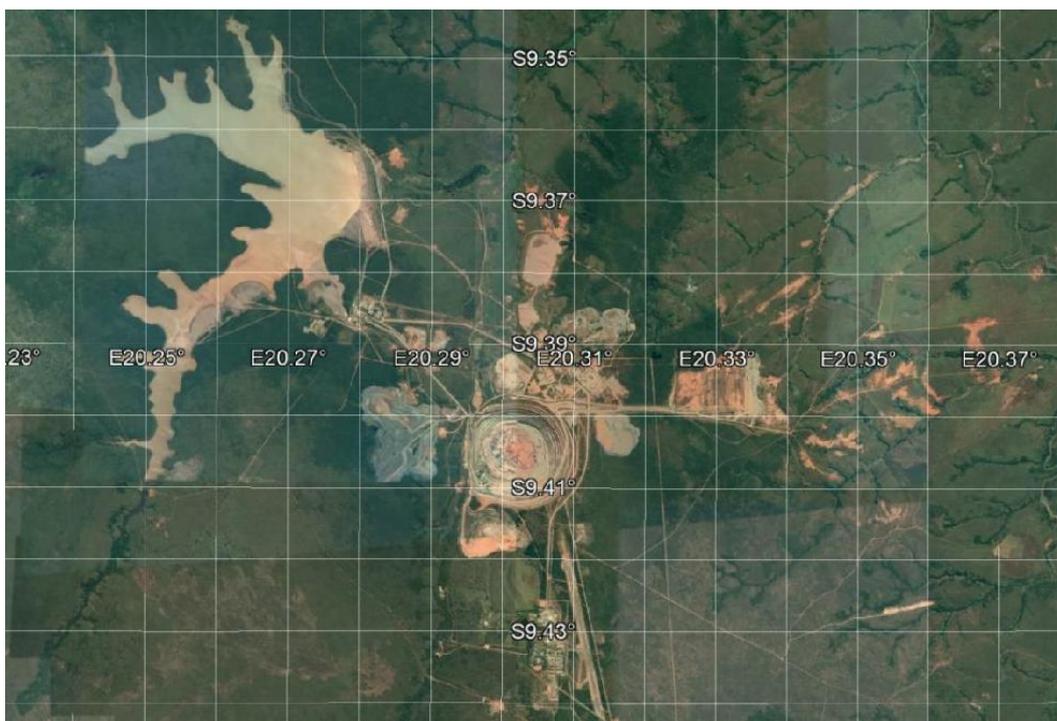
Since the beginning of August 2021, the riparian communities in the Kasai River Basin, along the Tshikapa and Kasai Rivers, have been experiencing an unprecedented environmental and human disaster, due to water pollution from mining activities in the headwater catchments located in Angola. The mining schemes identified in these areas include the Luo, Camatchia-Camagico and Catoca diamond mining in the Angola part of the Kasai River Basin.

**Fig. 1** Location of the pollution source in the Tshikapa and Kasai rivers from Angola

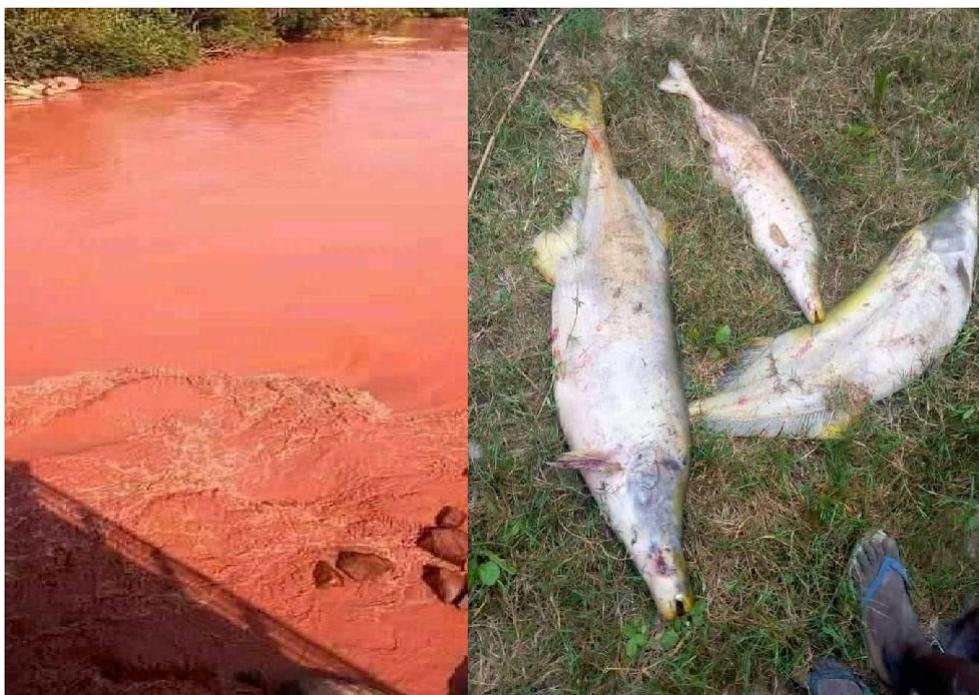
The immediate consequences of this disaster recorded so far include water pollution, poisoning and loss of aquatic fauna and flora, waterborne diseases for riparian communities, disruption of fishing and navigation activities, and lack of access to domestic water and recreation services.

*Fig. 2 Immediate effects of pollution disaster from the Tshikapa and Kasai Rivers in DR Congo*

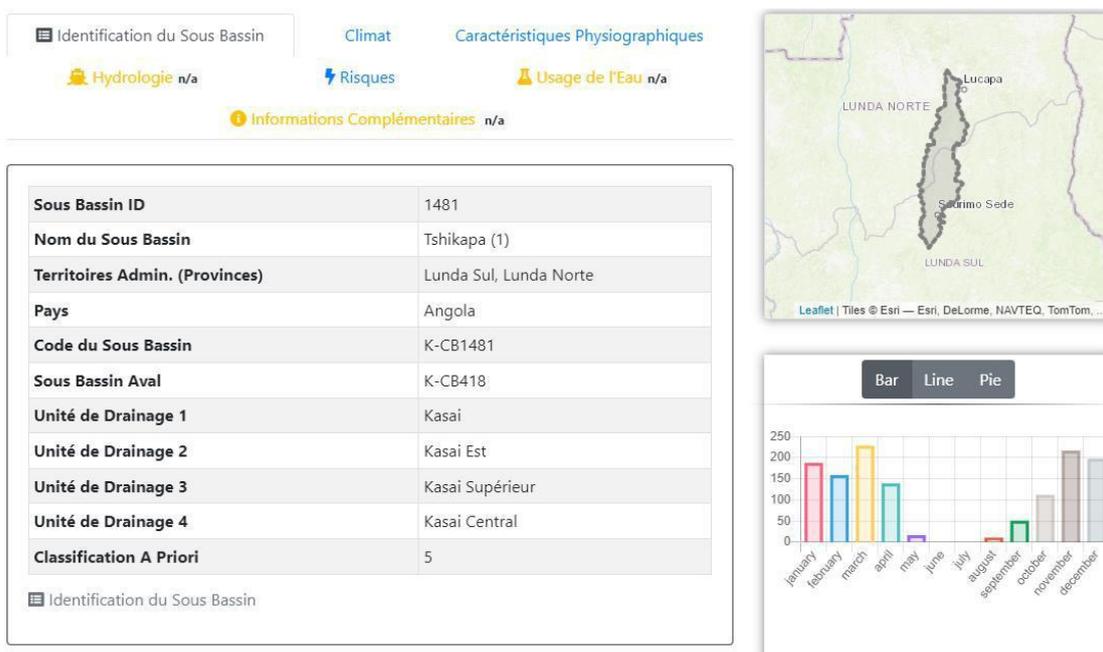
The figure below shows the source of pollution as identified in the CB-CIS, which refers to catchment ID 1481, located in the provinces of Lunda Norte and Lunda Sul in the Republic of Angola.

Fig.3 Extract of catchment characteristics from the pollution source in CB-CIS

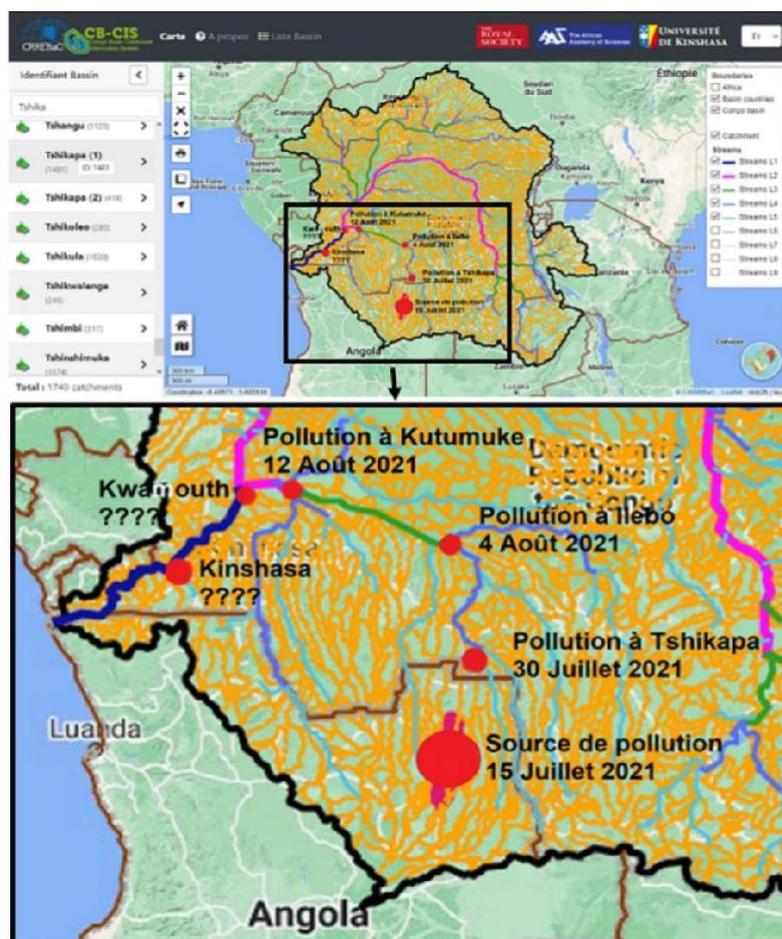
It was also possible to identify in CB-CIS the propagation of pollution for the downstream catchments, as presented in the figure and table below. Over **two million (2,000,000)** people are exposed to the risks of water pollution as identified from CB-CIS.

Fig.4 Source and diffusion of pollution as identified in CB-CIS

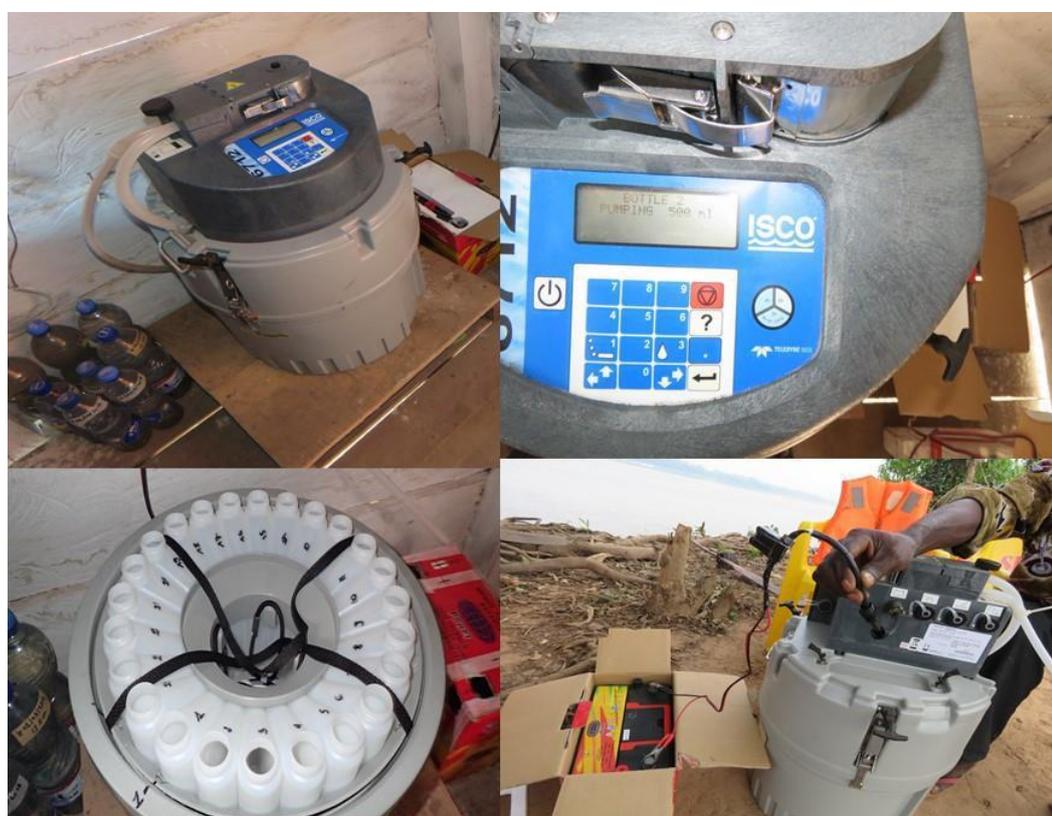
Since 2017, CRREBaC has been monitoring water flow (water quality and quantity) from its station along the Kasai River at the city of Kutmumuke, which automatically collects daily samples. This station implemented under the Royal-Society DFID funded research programme is the only complete station on the Kasai River that can be used to date to assess the situation before and after this tragedy. These measurements will need to be completed with other measurements upstream and downstream of the CRREBaC station, to assess the level of risk, and establish a response plan that will also support decision-making for sustainable water management in the Kasai River Basin.

**Fig. 5 Some equipment of the water monitoring station in the Kasai River**

- ✚ Assess the socio-economic and environmental impacts of pollution and propose mitigation and remediation measures;
- ✚ Strengthen the operational capacity of the CRREBaC monitoring station and duplicate this scheme in other sensitive areas, including mining and industrial areas, areas with high population concentration, and areas of unique biodiversity such as the Malebo Pool, which suffers pollution from anthropogenic activities throughout the Congo Basin;
